Enclosed with this letter are graphs of a portion of Mission FT-129 showing vehicle gyrations as determined by measurements of stationary targets on successive frames in both FWD and AFT cameras. Two other missions identified as GT-121 and GT-130 were also received but were of little value because of excessive cloud cover or insufficient overlap or both. The driver of the vehicle flying Mission GT-130 made several passes over the target array at EAFB but the passes were transverse to the array instead of parallel to them as had been criginally requested.

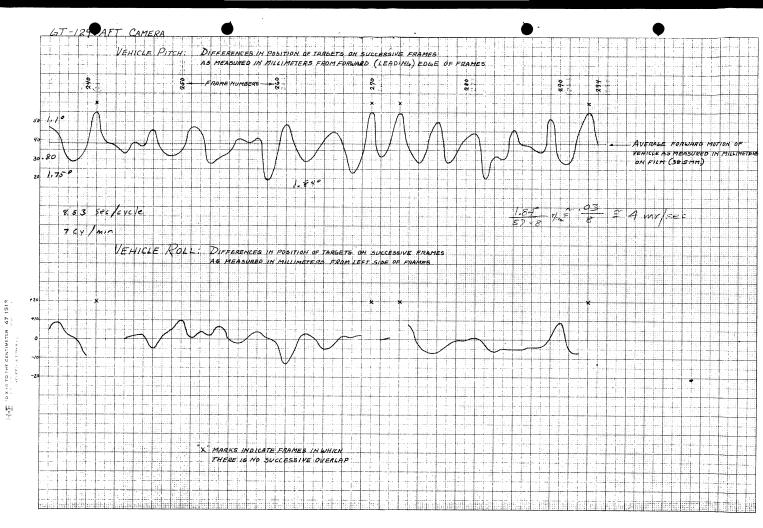
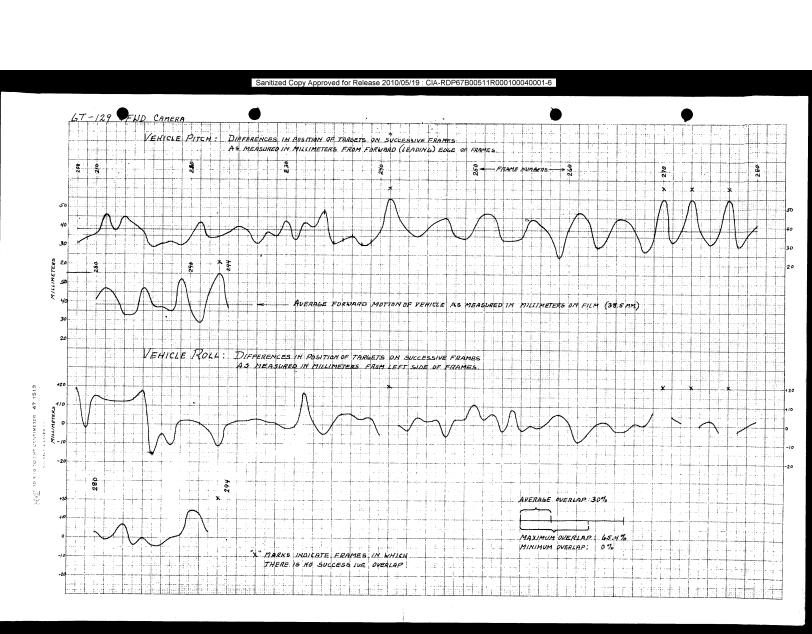
As in the previous mission which we analyzed, measurements from the forward edge of the frame to a stationary target near the center edge of the frame were measured with a millimeter scale. This was also done with the same target in the next succeeding frame in order to determine how far it had moved, and at the same time the position of a new target was measured in the succeeding frame. This was continued for as long as the vehicle was on a straight course, and the differences between the positions of the targets, as measured from the forward edge, were plotted. This gave information regarding pitch.

Information regarding roll was obtained in a similar manner, by measuring the distance of the same targets with a millimeter scale from the left edge of successive frames. Differences in position of the targets with respect to the left edge were then plotted.

If you will superimpose the plots of the FWD Camera over the AFT, aligning the frame numbers, you will notice an excellent correlation, which is, of course, to be expected. It might be well to note that vehicle roll was substantially less in this mission than in previous ones measured.
